DV5 Engine Repair & Upgrade.

## **TIMING CHAIN CONVERSION 21-0700 TIMING KIT SETUP**

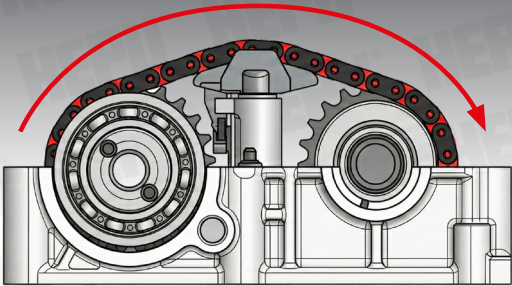
7 mm TIMING CHAIN ( PROBLEM ZONE )

#### 7 mm TIMING CHAIN – THE WEAK POINTS

- ✗ Excessive chain curvature ▶ increased stress on timing chain & camshaft sprockets
- ✗ High tensile forces ▶ rapid chain elongation
- ✗ EGR/DPF-related stress on the lubricant film ▶ additional abrasive wear
- ✗ By design, even a new 7 mm chain operates beyond its rated load capacity

**Result:** Noise development, tensioner wear, chain elongation - in extreme cases: chain failure

- Why replacing 7 mm with 7 mm is NOT recommended:**
- The 7 mm geometry represents a fundamental design flaw
  - The timing chain operates beyond its rated load capacity from the factory
  - Stronger 7 mm chains do not eliminate the root cause
  - The OEM has fully switched to 8 mm geometry

- Important for workshops:**
- Replace 7 mm ▶ 7 mm = problem remains
  - Upgrade to 8 mm = sustainable repair solution
  - Fewer warranty claims
  - Higher customer satisfaction

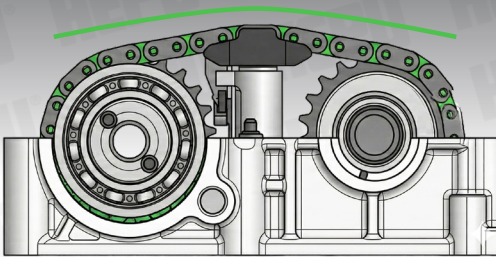
8 mm TIMING CHAIN ( SOLUTION )

WHY THE 8 mm SYSTEM IS THE PERMANENT SOLUTION

- ✓ Revised chain geometry and modified chain sprockets ▶ less chain curvature
- ✓ 16% wider chain ▶ higher tensile strength
- ✓ More stable operation ▶ no permanent overload conditions
- ✓ Significantly reduced chain elongation ▶ longer service life

**Recommendation:** For a permanently reliable repair, always install the complete 8 mm upgrade system.

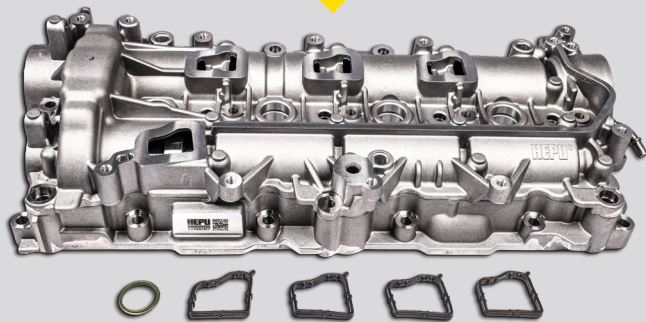
Also available as a pre-assembled version: **21-0700-AS**

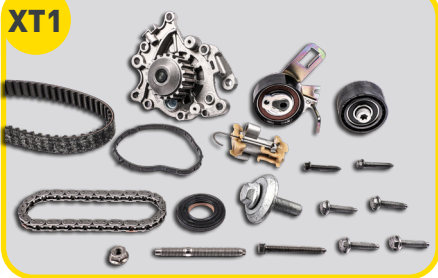
**XT1**

| MODEL YEAR | CHAIN WIDTH | TIMING CHAIN KIT | WATER PUMP KIT (incl. chain ) |
|---|---|---|---|
| Up to 2023 | 7 mm | 21-0695 | PK19010-XT1 |

**Notice:** 21-0695 / 21-0696 = Timing chain kit  
PK19010-XT1 / XT2 = Complete kits incl. timing chain, belt, tensioner and water pump

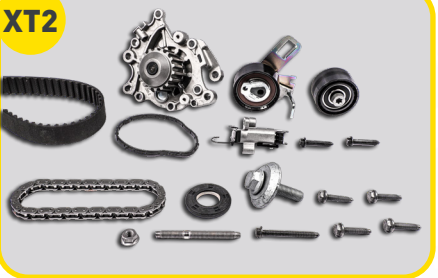
**XT2**

| MODEL YEAR | CHAIN WIDTH | TIMING CHAIN KIT | WATER PUMP KIT (incl. chain ) |
|---|---|---|---|
| From 2023 | 8 mm | 21-0696 | PK19010-XT2 |
